Distributed Optical Fiber Sensing Bonding Techniques Performance for Embedment inside Reinforced Concrete Structures

Abstract: Distributed optical fiber sensors (DOFS) are modern-day cutting-edge monitoring tools that are quickly acquiring relevance in structural health monitoring engineering. Their most ambitious use is embedded inside plain or reinforced concrete (RC) structures with the scope of comprehending their inner-workings and the functioning of the concrete-reinforcement interaction. Yet, multiple studies have shown that the bonding technique with which the DOFS are bonded to the reinforcement bars has a significant role on the quality of the extracted strain data. Whilst this influence has been studied for externally bonded DOFS, it has not been done for embedded ones. The present article is set on performing such study by monitoring the strain measurement quality as sampled by DOFS bonded to multiple rebars with different techniques and adhesives. These instrumented rebars are used to produce differently sized RC ties later tested in tension. The discussion of the test outputs highlights the quasi-optimal performance of a DOFS/rebar bonding technique consisting of inc

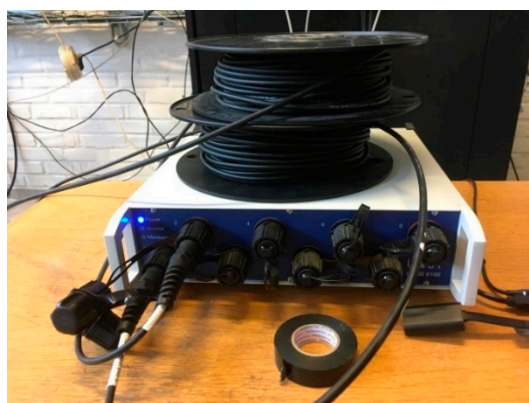
Figure 1. LUNA's ODiSI 6000 Optical Backscatter Reflectometer.

Distributed optical fiber sensors (DOFS) are modern-day cutting-edge monitoring tools that are quickly acquiring relevance in the structural and civil engineering field [3]. These are very thin glass wires able to accurately measure strains (down to $1 \mu\epsilon$), temperature and vibration in 2 or even 3 dimension [4]. This can be achieved in a completely-distributed manner (modern interrogation units can attain a spatial resolution of 0.63 mm) and with measurement frequencies of 250 Hz [5]. Thus, direct detection and characterization (including recognition, localization, and quantification or rating) of local strain changes generated by structural damage are intrinsic properties of such sensors. Furthermore, optical fiber sensors have some inherent advantages such as corrosion immunity, high durability, resistance to electromagnetic interference, small size and light weight that elevate them beyond the classic monitoring tools [6]. The functioning of these sensors is based on the fact that, assuming the characteristics of the light transmission within a fiber well known and the latter properly calibrated, any alteration (due to temperature and strain) are detected through back-scattered light by the optical backscatter reflectometer (OBR) (see Figure 1) and are finally translated to strain variation in each of the DOFS' points [7].

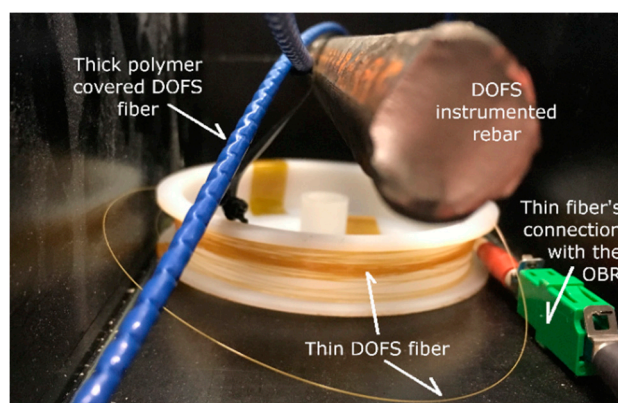
Figure 2. Thin polyamide cladded distributed optical fiber sensors (DOFS) (yellow) and thick polymer coated DOFS (blue).

The simplest DOFS sensor is a polyamide cladded glass wire which boasts a $125 \mu\text{m}$ diameter (see Figure 2). Multiple commercially available variations cover the latter with differently sized coating layers which span from rigid and deformed polymeric coatings (blue thick fiber in Figure 2) to thin fabric-like covers that consent a large amount of fiber winding.

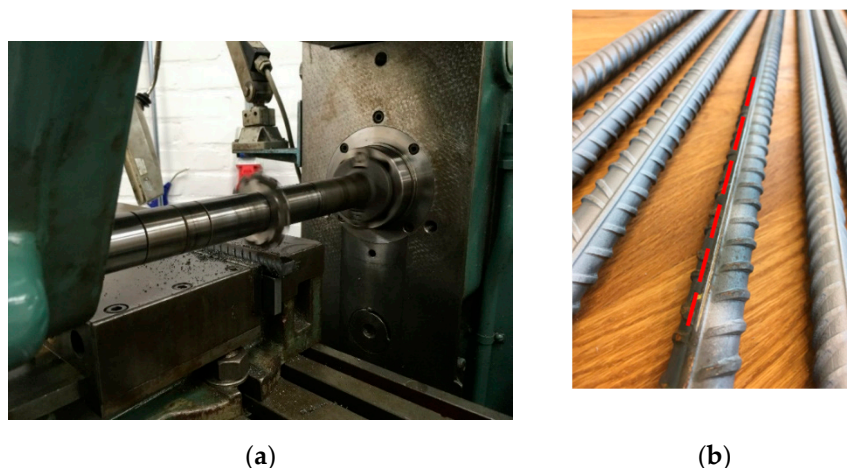
Figure 3. (a) Milling of the groove along the rebar's longitudinal rib and its (b) resulting incision marked with a dashed red line.

A rather novel and advanced DOFS protection technique establishes the incision of a groove on a rebar's surface (usually on the longitudinal rib as in Figure 3) which later welcomes the DOFS inside it. As will be visible in the following publications, this is believed to provide further protection compared to simply gluing the fiber to the rebar's surface (Quiertant et al. [24]). Yet, it is quite surprising that, despite this technique's non-negligible financial and time costs, a comprehensive study on the potential improvement that it brings to the table (in terms of DOFS reading quality) has yet to be performed. The present paper intends to perform such analysis.

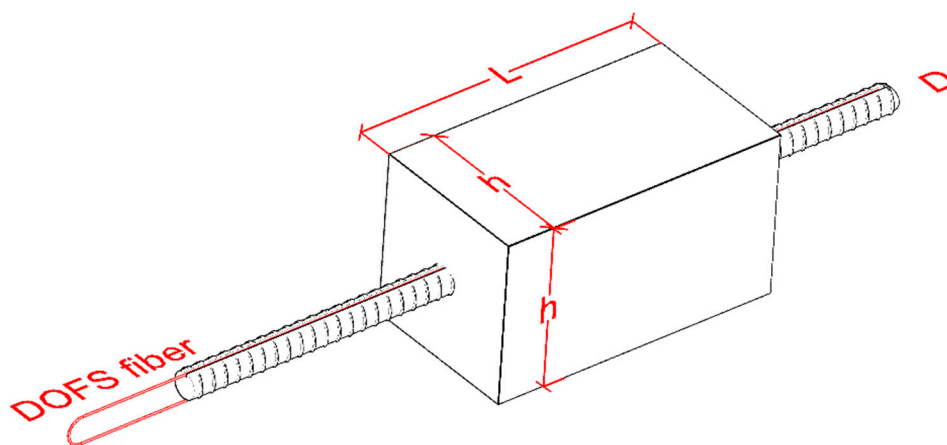
Figure 4. Reinforced concrete (RC) ties' general geometrical dimensions.

The present paper displays the results of an experimental campaign developed on multiple squared RC ties with DOFS-instrumented rebars. Each of the RC members will be indicated with a code such as 15D20_24 that should be interpreted in combination with Figure 4, which provides indications on the geometrical features of each RC member.

The first digits of the code are representative of the concrete prism's cross sectional size (h in Figure 4), the digits that follow the letter D are representative of the diameter of the rebars (D in Figure 4) whilst the digits following the underscore symbol ($_$) are representative of the length of the concrete prism (L in Figure 4). The geometrical design of these RC members satisfies the conditions necessary to perform a double pullout test-powered study [29] on the influence of the longitudinal dimensions of a RC tie on the bond stress/slip present in the interface between rebar and concrete; topic of future publications.

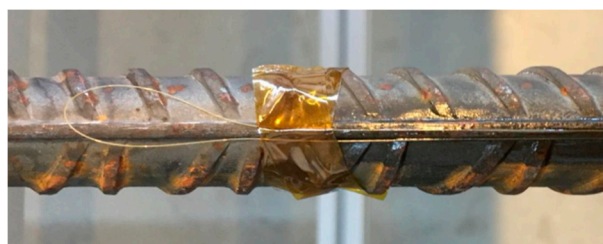
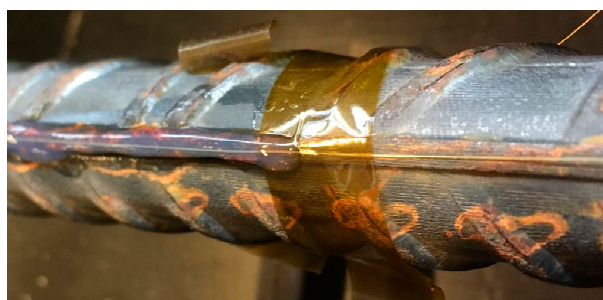
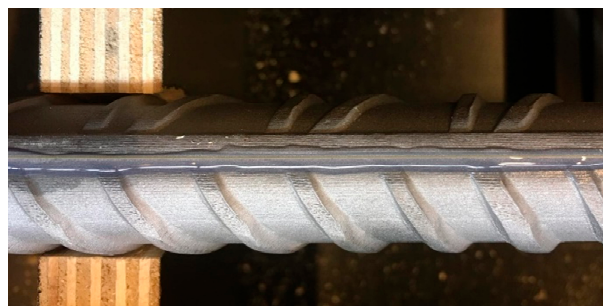
Figure 5. Graphical and photographic representation of the three tested bonding techniques (a) positioning of DOFS in an incised groove and bonding it with CYN (b) bonding it with CYN with an additional protective layer of SI (c) positioning of the DOFS in a groove, bonding through CYN and protection through SI.

The bonding technologies in use, illustrated in Figure 5, are the following ones:

1. DOFS positioned inside a groove and bonded with cyanoacrylate (CYN) as visible in Figure 5a;
2. DOFS glued to the rebar's surface with CYN with a protective layer of silicone (SI) on top, as visible in Figure 5b;
3. DOFS positioned inside a groove, bonded with CYN and further covered with SI. As visible in Figure 5c.

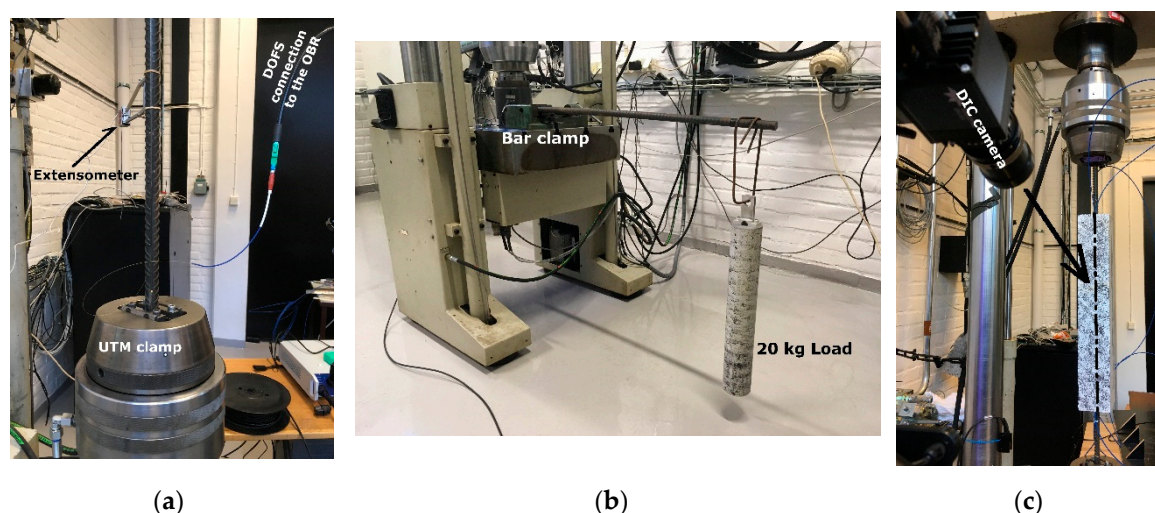
Figure 6. Test setup for the (a) universal testing machine (UTM)-assisted tensile test on a bare rebar (b) bending test (c) UTM and digital image correlation (DIC)-assisted tensile test on a RC tie.

The bending test is instead achieved by clamping one extremity of the rebars and applying on the opposite one (at a fixed distance) a 20 kg load (Figure 6b) in order to create a bending stress and a clearly distinguishable strain profile. Once again, this process is done twice in order to monitor the instrumented rebars strains with a CYN-bonded DOFS and later a CYN+SI bonded DOFS.

later their testing by means of the UTM (as visible in Figure 6c). This last test is integrated with a DIC monitoring of the RC ties' surfaces aimed at studying the crack formation, evolution and relation with the interiorly sampled rebar strains. The loading program is a simple displacement-controlled monotonic tensile load increased at a speed of 1.5 mm/min until yielding of the rebar.

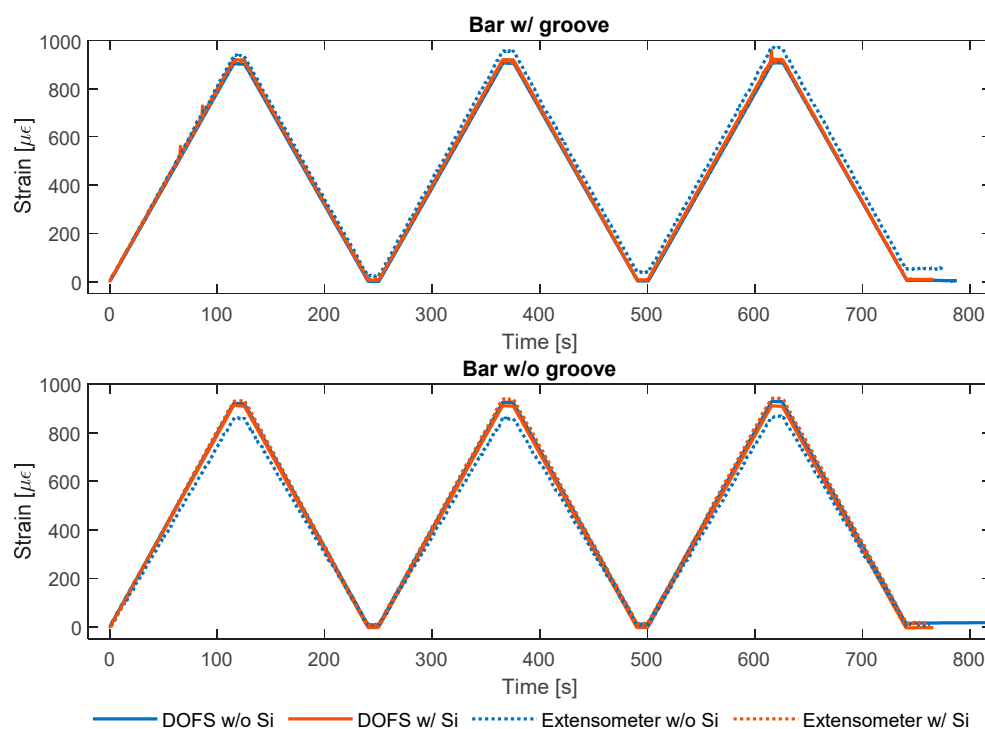
Figure 7. DOFS and extensometer output readings of the tensile test.

Figure 7 plots the strain measurements performed by the DOFS and by the extensometers connected to the two rebars w/groove and w/o groove. As visible both graphs include two pair of readings, one (in blue) representative of the strains recorded by the DOFS glued with CYN and the other (in red) representative of the strains recorded by the same DOFS glued with CYN and covered with SI. An excellent agreement is present between the DOFS strain curves of both graphs indicative of the small influence that a layer of SI exercises on the tensile readings of a bare bar. Such agreement outshines the ones of the classic extensometer. Moreover, for the case of the bar w/groove, the extensometer even fails to detect that the zeroing of the applied load at the test's end whilst DOFS actually does. The extensometer's lower readings quality is definitely a function of how/where the tool is attached on the rebar compared to its transversal ribs but, then again, it is an uncertainty that is entirely surpassed by DOFS. Figure 8 plots in more detail the strain reading differences of the two rebars when SI is present and when it is not. As DOFS' does not surpass $15 \mu\epsilon$ in either bar (an amount possibly induced simply by a variation of the grip position), it can be safely stated that in tension the presence of SI does not influence the strain readings and thus it is safe to apply it for further protection of the fiber. For the extensometer, instead, the reading variations are expectedly higher for both bars suggesting, once again, the greater reliability of DOFS. Finally, as can be seen in Figure 7, the presence of a groove also does not seem to alter the strain readings suggesting that it too, in tension, can be inserted sans souci as an extra protection for the fiber.

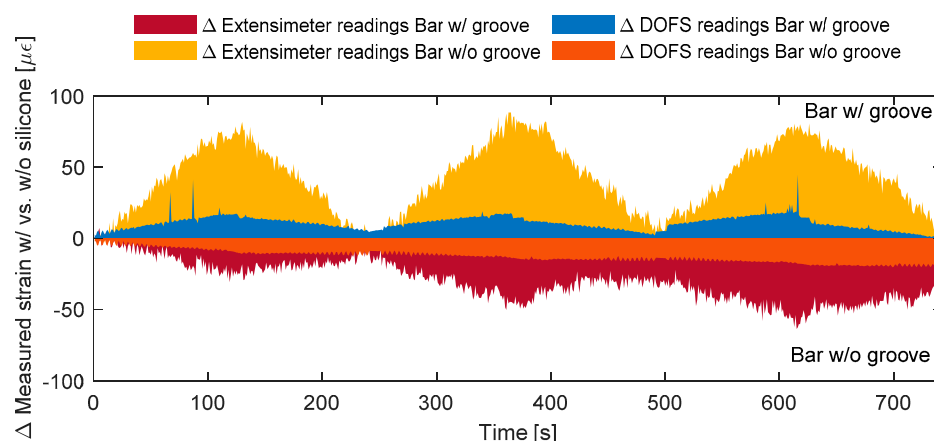
Figure 8. Bar w/groove and w/o groove's strain reading differences when DOFS + cyanoacrylate (CYN) are or are not covered by silicone (SI).

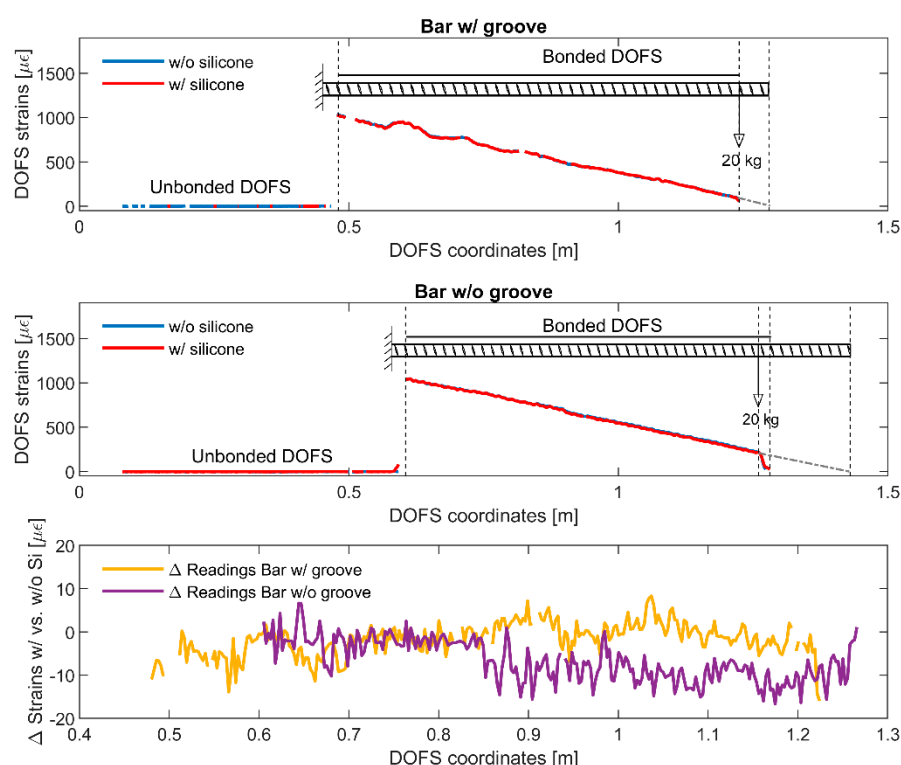
Figure 9. Strain profiles of the rebars (w/and w/o groove) under bending and the difference of values w/and w/o SI.

Moving on to the bending test, Figure 9 plots the DOFS strain measured in absence (in blue) and in presence of a SI protection layer for both bars w/and w/o groove. Due to the difference of DOFS bonding length in the two rebars, an illustration of the latter is inserted in both plots in order to help the reader better comprehend the shape of strain profiles.

It should be kept in mind that the initial segment of the graph, oscillating around the value of $0 \mu\epsilon$, is simply denoting the strains inside the un-bonded and loose section of the DOFS. Only once the first DOFS section of the fiber is bonded, then the profile jumps upwards reporting the rebar's highest strain. Once again, the presence of silicone is hardly perceptible, as confirmed by Figure 9's bottom graph, leading to quasi-identical strain profiles. Once again, the largest recorded strain measurement difference between SI covered bars and not is around $15 \mu\epsilon$ for both rebars. The presence of the groove too, hardly influences the DOFS readings. Indeed, the difference between the rebar w/and w/o groove

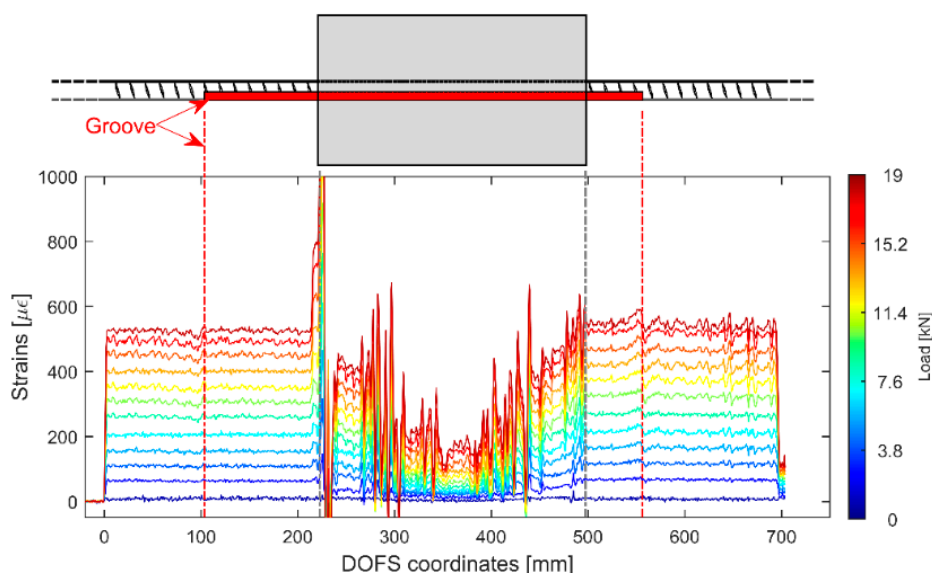
Figure 10. Strain profiles of a 15D20_27 RC tie test with the DOFS bonded with a combination of groove and CYN.

The first tested RC tie was a 15D20_27 member with its DOFS positioned in a groove and bonded with strictly CYN (no protection layer was placed). The test was intended to substantiate whether the mere presence of the groove could guarantee sufficient protection to the DOFS without requiring an extra protective layer. Figure 10 displays some of the strain profiles extracted from the aforementioned test along with an illustration of the member's geometry in order to properly correlate the plot data with the actual physical surface/surrounding in which the DOFS is located. As visible, the profiles' sections corresponding to the segment of the instrumented rebar embedded inside the concrete is full of SRAs (induced by the concrete's friction on the unprotected DOFS) making the actual profile barely readable. This is in line with multiple results reported in the literature review, thus leading to the conclusion that this technique most definitely is not recommended for this kind of DOFS-monitored testing. Yet, it should be mentioned that a possible influencing parameter could be the actual depth of the groove (quite shallow in the present test). It is possible that the deeper it is the better protection it provides to the rebar.

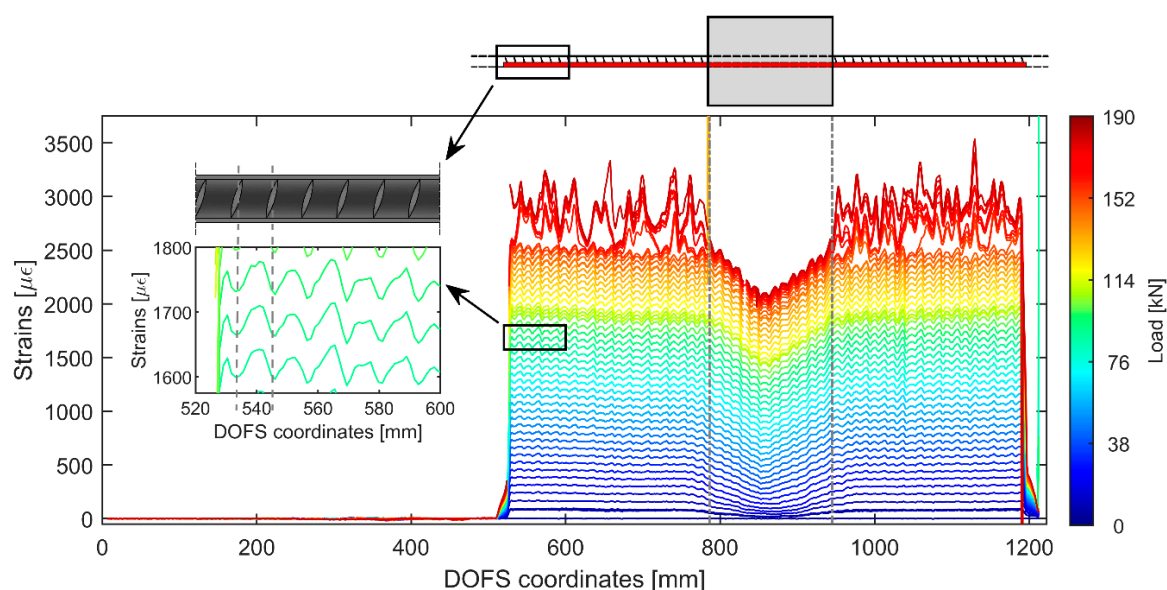
Figure 11. Strain profiles of a 15D20_21 RC tie test with the DOFS bonded with a combination of groove, CYN and SI.

Figure 11 displays the strain profiles of a 15D20_21 RC tie where the DOFS is first positioned in a groove and then bonded with CYN and SI.

As can be seen in Figure 11 the profiles are much better than Figure 10's as a testament to the higher performance of its bonding technique. Indeed, hardly any SRAs are visible and the strains are monitored all the way to the yielding load (around 167.5 kN) and beyond. The peaks present at the higher loads are not SRAs (as was the case in Figure 10) but rather the physical representation of the rebar's different sections slowly plasticizing one after the other and therefore giving way to drastically higher strains than the non-plasticizing sections.

Moving back to Figure 11, a small zoom is provided on its left of the rebar's strains profile outside of the concrete as reported by DOFS. An oscillation of the profile is visible which could easily be confused with signal noise. Yet, it is not noise but rather the influence of the transversal rib on the performance of the rebar. As a matter of fact, whenever a rib is present, the cross-section of the bar is automatically larger therefore the carried stress (and consequent steel strains) is inferior. Oppositely, whenever the rib is absent the carried stress is higher. The reiteration of this pattern leads to the abovementioned oscillating profiles. Yet, unless a researcher is interested specifically in the rib's influence on the bar's performance, the latter can be considered signal noise as the useful information signal that is usually pursued is strictly the global profile of the strain curve. As will be visible later on, this particular noise is also a function of the bonding technique in use, thus it is automatically elected as a study parameter for establishing the most performant bonding technique. In order to separate the noise from its original signal (as in Figure 13) a Fourier filtering solution can be used, thus relating a signal sampled in time or space to the same signal sampled in frequency, or a moving-average filter, thus sliding a window of customizable length along the data and computing the averages of the data contained in each window. For the scope of the current work the latter is deemed to be sufficiently performant, hence it is the used methodology.

What is also noticeable in Figure 11, is that the magnitude of such newly defined rib-induced noise becomes increasingly larger with the load thus increasingly disturbing the sought-after signal. Figure 13 shows its occurrence for member 15D20_21's six study case stages along its test. The latest of these stages has average noise peaks of height $27.5 \mu\epsilon$ which, considering its corresponding load of 154 kN, is still very reasonable. As per the bottom graph of Figure 13, the average strain reading noise seems to be increasing at a regular pace with the load suggesting a correlation between the two.

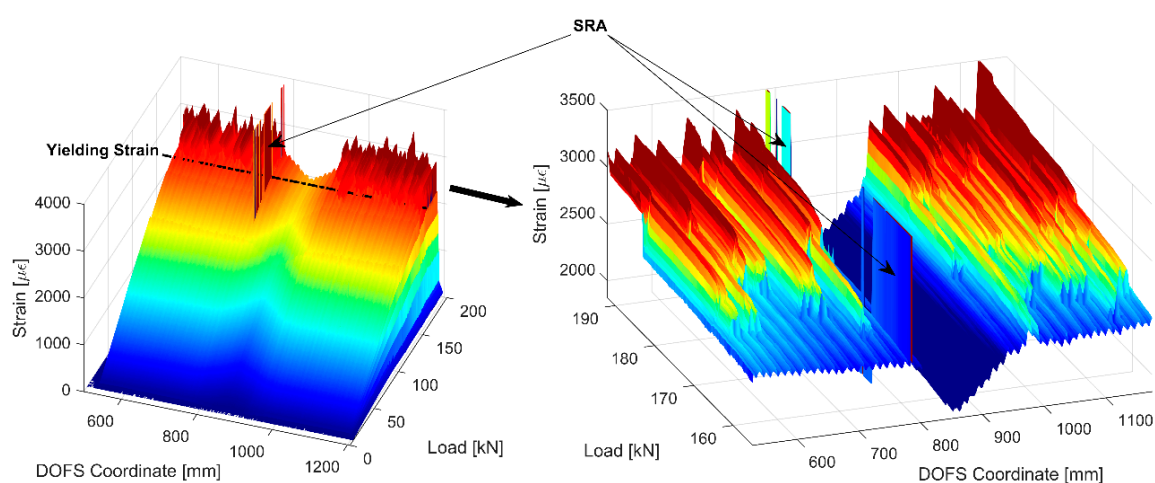
Figure 12. Three-dimensional representation of the strain evolution of member 15D20_21 with a zoom of the higher strains showing the progressive yielding of the different cross-sections of the rebar.

Figure 12 provides a three-dimensional representation of member 15D20_21's strains displaying a smooth increase up until the yielding strain ϵ_{sy} beyond which it is visible how little by little all the rebar's cross sections progressively plasticize (indicated by a sudden peaking of the strains).

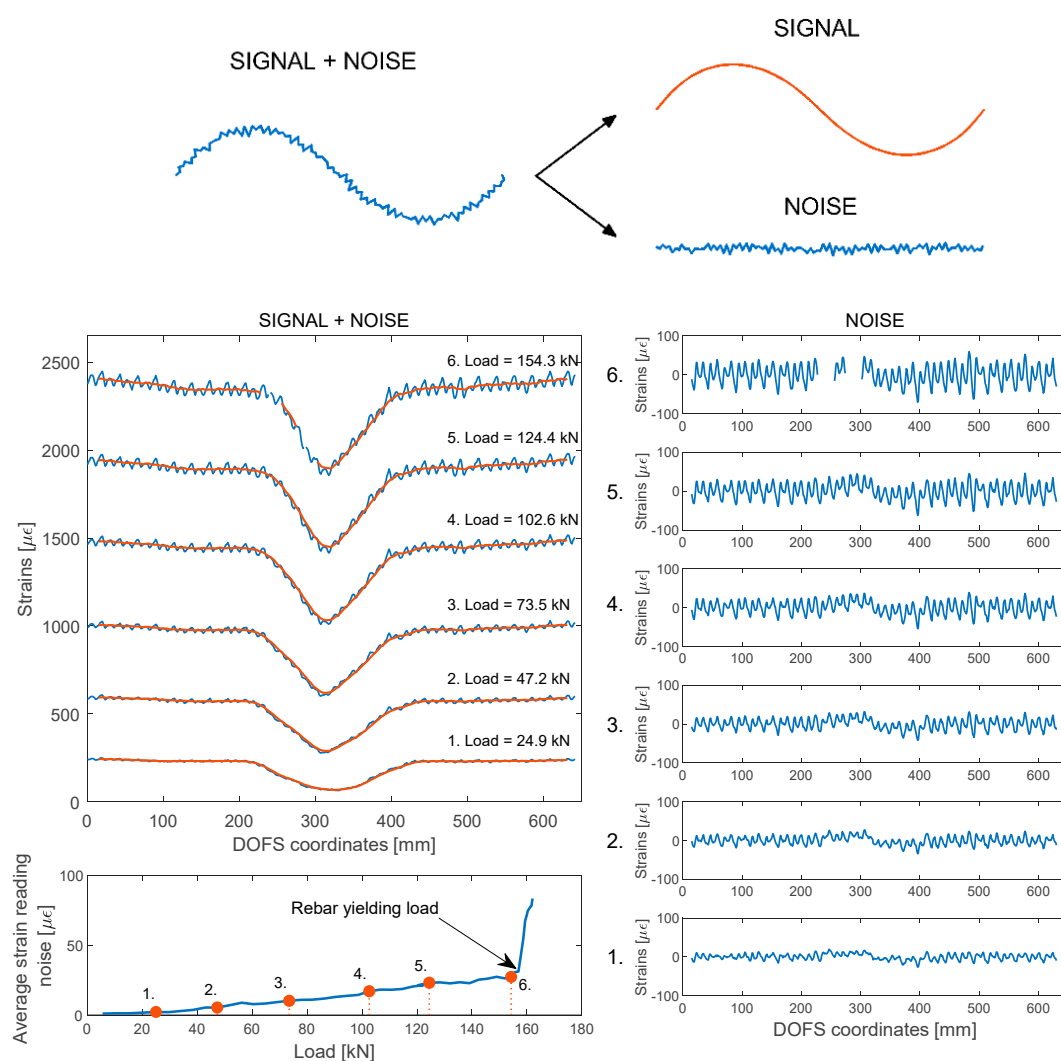
Figure 13. Distinction of signal and noise for an example curve (top) and evolution of the rib-induced noise with the load of member 15D20_21.

This was expected since, being the oscillations caused by the presence of the transverse ribs, the absorbed stress taken by the latter should also increase linearly with the load while in the elastic range. The only moment when the latter is broken is when the steel's yielding stress is reached. Beyond this point, as seen in Figure 12, large peaks start forming wherever the rebar's cross-sections start yielding.

What is also on view is that, just like in Figure 13, the noise magnitude increases linearly up until the yielding load. Therefore, henceforward the noise level magnitude can be studied simply by means of a fitted straight line's slope coefficient. For example, Face A's versus Face B's average strain reading noise slope coefficient when inside the concrete is 0.3636 versus 0.0360, indicating the latter's higher quality. Now that the basic concepts of the rib-induced noise and its way of quantifying it have been introduced, the other members' analysis will be performed jointly at the end of this section.

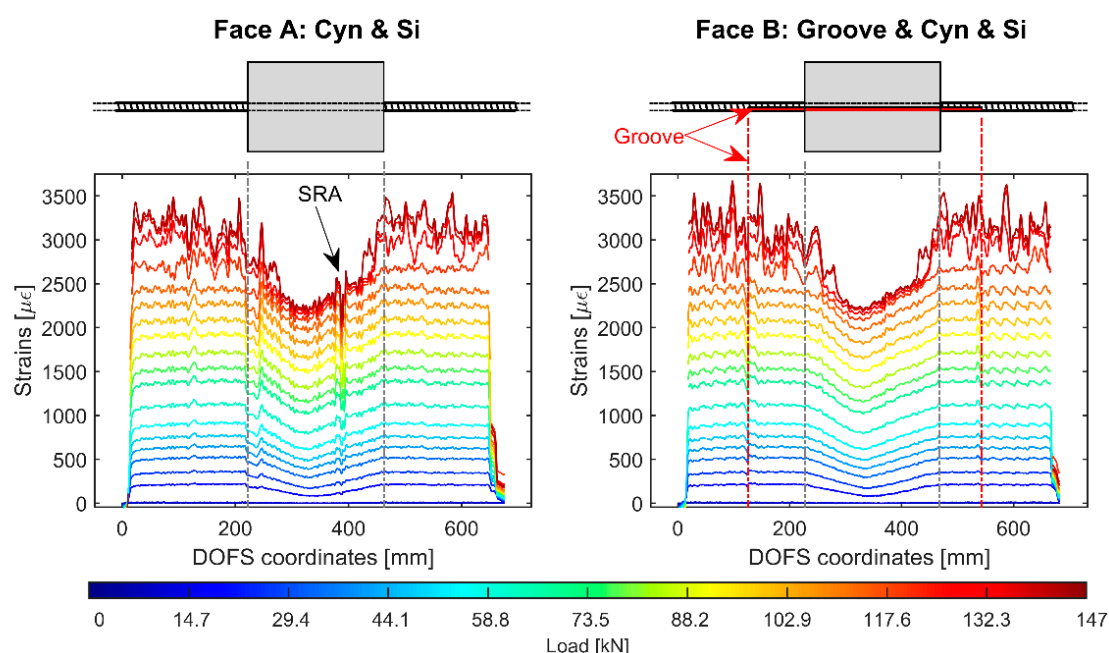
Figure 14. Strain profiles of 15D20_24_1 RC tie test with the DOFS bonded on both sides of the rebar by means of CYN and SI on one side (Face A - left) and a groove + CYN + SI on the other (Face B - right).

Moving on to the following RC tie, Figure 14 displays the DOFS strain readings of the first of two 15D20_24 members (henceforth referred to as 15D20_24_1) with its DOFS being bonded on its opposite faces. One face (henceforth referred to as Face A) uses CYN and SI whilst the opposite (Face B) adds a groove. The latter, though, is not as long as the rebar itself (see Figure 14's Face B RC tie illustration) therefore allowing to check, on a single face, the DOFS reading performance of two separate bonding techniques. What can be quickly spotted is the larger amount of noise that characterizes Face B's readings when performed outside of the groove versus inside it. Furthermore, along with a higher noise level of the signal, Face A's plots seem to include more SRAs. This is potentially due to the lack of a protective groove on its side.

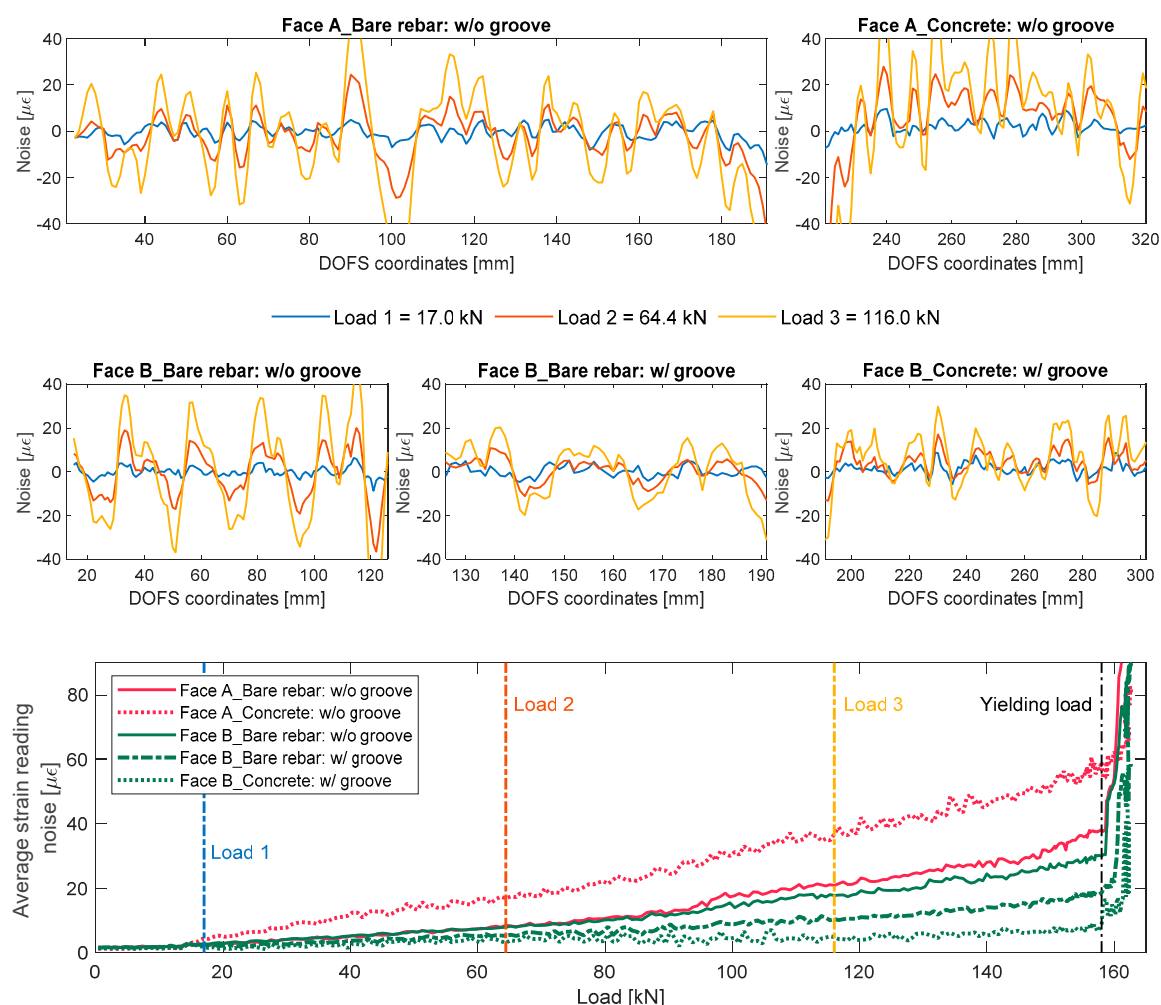
Figure 15. Rib-induced noise analysis of the outputs of member's 15D20_24's test (top five subplots) and of their relative average reading noises (bottom subplot).

Figure 15 dwells deeper in the DOFS' signal noise, displaying its values under three load levels. A discrete noise magnitude difference is noticeable according to the difference of DOFS/rebar bonding technique and according to the presence or absence of concrete. Figure 15's lower plot summarizes the increasing noise magnitude as a function of the load.

Both faces of the rebar report similar high noise levels whenever the DOFS is bonded outside of the groove whilst lower levels are consistently reported (both outside and inside the concrete) whenever the DOFS is positioned inside it. Once again it seems that the presence of the groove translates in an improved signal quality both from a noise and anomalous point of view.

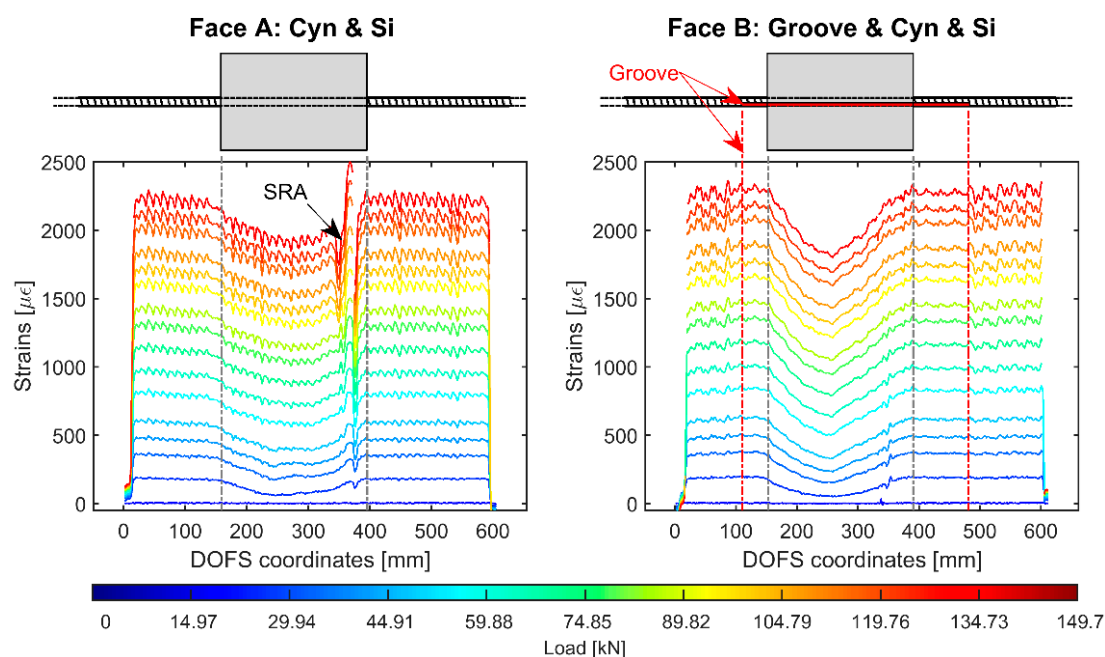
Figure 16. Strain profiles of 15D20_24_2 RC tie test with the DOFS bonded on both sides of the rebar by means of CYN and SI on one side (Face A - left) and a groove + CYN + SI on the other (Face B - right).

Figure 16 displays the DOFS strain measurement of an identical member, 15D20_24_2, with also identical bonding techniques.

The reason behind the testing of such member was the idea of attempting the replication of the previous member's results in order to consolidate them. While most of the above conclusions still apply to the present member (the presence of the groove providing the least noisy and anomalous results both inside and outside the concrete), an unforeseen phenomenon also came up. Indeed, whilst in Figure 14 both faces provide similarly shaped plots, Figure 16's are quite different. Face A's profile inside the concrete loses the central pointy tip (expected in RC tie tests) and appears more curvilinear (instead of the expected pair of crossing linear profiles). Such difference can be attributed to a non-overlookable bending of the RC tie during the test, induced by a lack of straightness of the bar itself. Unfortunately, discrete amounts of bending occur in numerous RC tie tests due to the impossibility of having perfectly straight rebars. Whilst this is an accountable phenomenon, the effect of such bending on the DOFS (or on the adhesives bonding it) is unseen and deserving of further studies. A possible explanation to Face A's profiles could lay in the additional stretching that the bending-induced-tension of the concrete communicates to the adhesives (especially on the very deformable silicone) and thus to the fiber. Additionally, further studying should also be dedicated to assessing the effect of bending-induced-compression. This is in line with other researchers' results [11,16] that suggest a certain "strain relaxing" and "strain redistributing" influence of the silicone when it is used as a DOFS protecting material. Unfortunately, this phenomenon strongly influences the recommendability of the present bonding technique for this particular use. Furthermore, it should be kept in mind that such alteration is truly revealed only when monitoring multiple facets of the same rebar. Indeed, if only a single DOFS deployment is performed, all that is extracted from the test is such altered data is with no way of assessing its correctness.

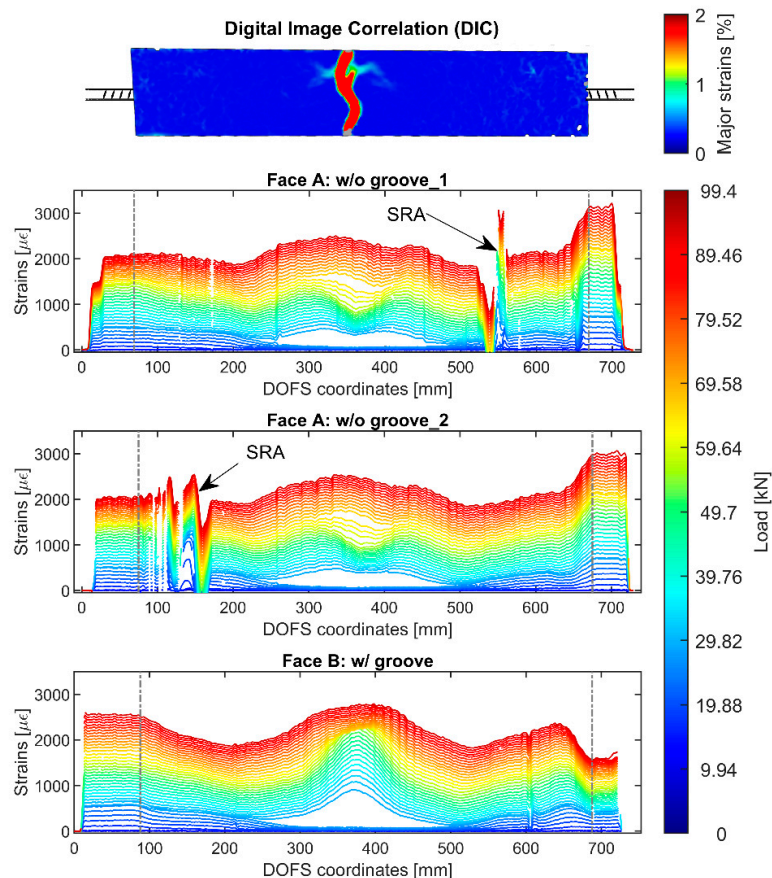
Figure 17. DOFS extracted profiles of member 12D16_60 as monitored by three runs of the same fiber, two on Face A and one on Face B.

The first RC cracking tie under scrutiny is 12D16_60. The member has the peculiarity of being monitored by three runs of the same fiber (possible thanks to its extended length) achieved through a simple twist, as shown in Figure 5a. Two DOFS runs are performed on Face A, where both bondings are achieved with CYN and SI w/o groove, and one on Face B w/groove (with CYN and SI). Their outputs are plotted in Figure 17 which includes a DIC illustration (on top) of the position of the crack in order to correlate it to the member's rebar strains.

Despite a relevant amount of bending is evident in each of three plots, a clear variation of the strain profile can be noticed in correspondence to the formed crack. Indeed, this variation takes the form of a single (Face B) or double pointed (Face A) peak whose axes coincides with the crack displayed in the DIC. Multiple SRAs can be seen in both of Face A's plots whilst only a small un-intrusive one can be spotted in Face B's suggesting the superiority of the latter's bonding technique. In line with what was concluded in the previous sub-section, also the noise produced by the combination of groove, CYN and SI is inferior to the bonding technique using just the last two elements.

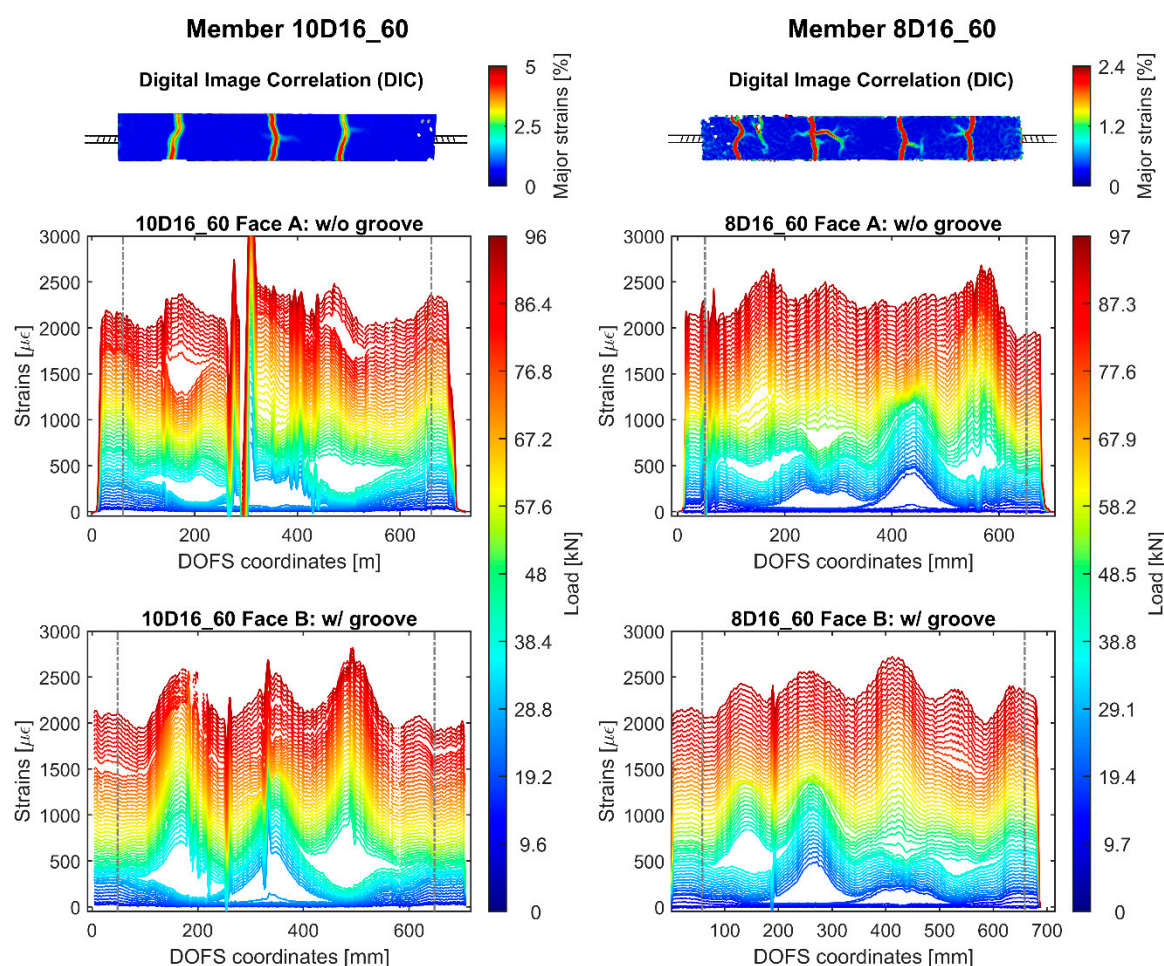
Figure 18. Member 10D16_60 (left) and 8D16_60's (right) rebar DOFS strain profiles for the latter's opposite faces, each welcoming different bonding techniques, and their DIC monitoring.

Figure 18 expands on the previous one showing the DOFS and DIC outputs of members 10D16_60 and 8D16_60. Just like before, the members' Faces A use simply CYN and SI whilst Face B adds a groove to the mix. Similar observations to the previous figure's can be performed. Indeed, strain peaks correspond well to DIC's cracks location and the signal noise level is inferior for DOFS positioned inside a groove versus outside one. Interestingly, though, member 10D16_60 displays a consistent amount of SRAs in both faces demonstrating that even the combination of groove, CYN and SI is not completely fail-proof.

Ideally, the steel rebar's strains in the cracked section (where concrete is absent) should be equivalent to the steel strains present on the bare rebar outside of the concrete prism. Yet, due to the presence of bending in the rebar, this assumption cannot be made. Furthermore, member 10D16_60's two plots display two different crack-induced peak heights, Face A's smaller than Face B's. As

Member's 10D16_60 crack-induced strain peak height difference between Faces A and B, could potentially be attributed to the two following issues; the above mentioned extra-stretching communicated to the DOFS by the bending-induced-tension inside the concrete and/or to the under-performance of SI which fails to properly isolate the DOFS from the concrete's pull whenever the latter's cracks open. Differently so, this issue was less pronounced for both fibers deployed in member 8D16_60 probably due to either a positioning of the DOFS half way between the bending-induced tensile and compressive area or to a thicker and more protective layer of SI. Further research is necessary to comprehend this phenomenon as no sufficient data is available at the present moment.

- An unexpected phenomenon, possibly connected to the under-performance of the above bonding technique, causes an alteration of the DOFS strain readings whenever the fiber is in the presence of extra bending-induced tension (smoothened strain profiles as in Figure 16, Face A) and/or monitoring strains in cracked cross-sections (magnifying their amount as in Figure 18);

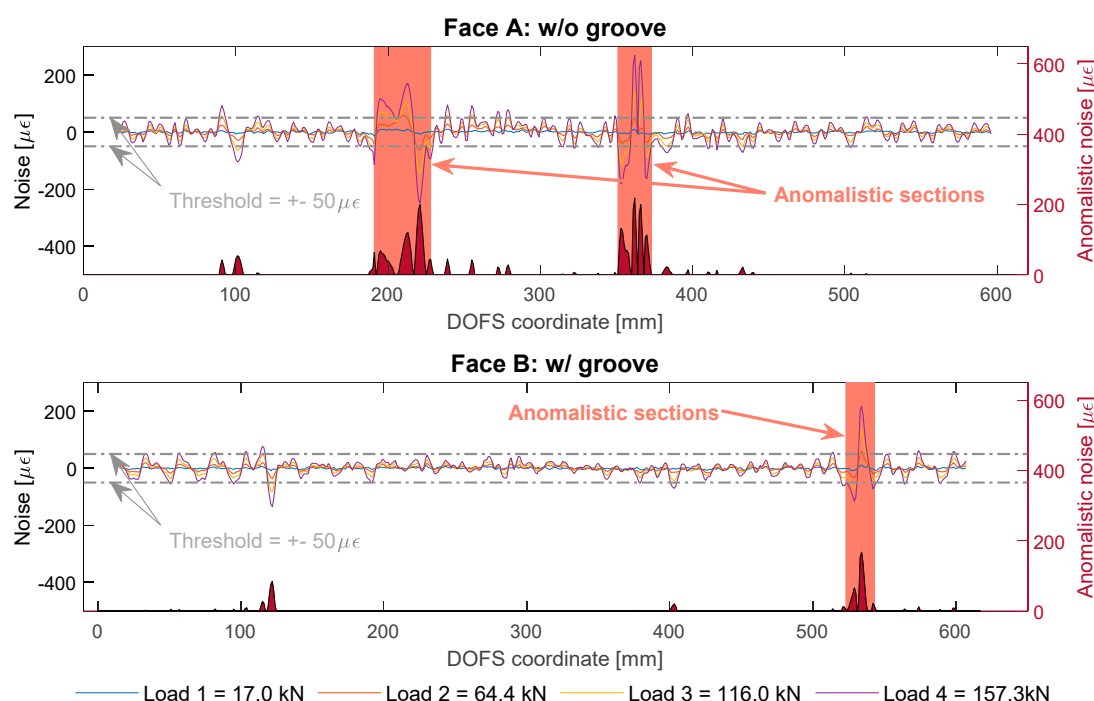
Figure 19. Member 15D20_24_2 Face A's (top) and B's (bottom) noise level study for SRA analysis.

In order to properly diagnose an SRA and clearly distinguish it from the signal's noise, a unique method is here presented. Taking as example member 15D20_24_2, Figure 19 analyses its DOFS signal noise level for four distinct loads.

For clarity purposes, being the noise increasingly larger with the load, only the latter will be studied on the lookout for SRAs. Then, if to assume a customizable threshold of $\pm 50 \mu\epsilon$, any noise level higher than the latter can be considered anomalous. The selected threshold may vary according

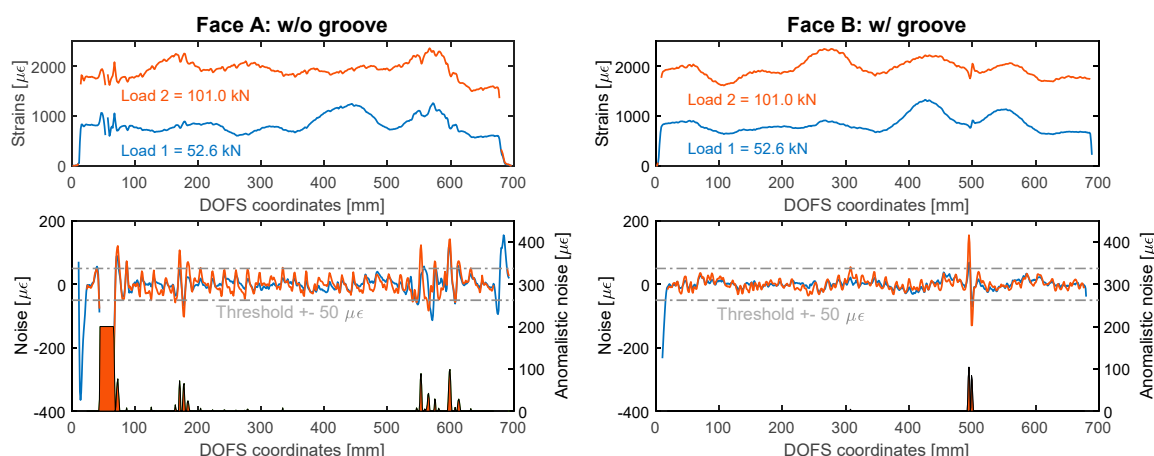
Figure 20. Member 8D16's strain profiles (**top**) and noise level (**bottom**) study for strain reading anomalies (SRA) analysis.

Whenever data is absent it can also be considered an anomaly as the viewer is also missing out on relevant information just like with an SRA. Except that, whilst with small SRAs a trend can still be distinguishable, with absent data no such thing can be done. Therefore, the used SRA detection code was tweaked to attribute an anomalistic noise of $200 \mu\epsilon$ to any DOFS section with missing data (as visible in Figure 20).

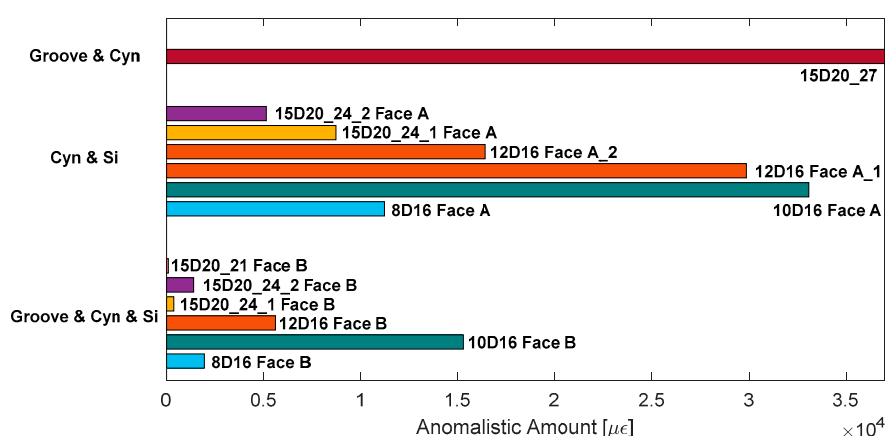
Figure 21. Total amount of anomalistic readings grouped per bonding technique used.

With these observations in mind a final calculation of the total amount of SRAs can be performed per every bonding technique. Its outcome, represented in Figure 21, shows a clear advantage of the groove, CYN and SI technique as it averagely welcomes a distinctly smaller amount of SRAs compared to the other two.
